Assessment methods of network technical condition

Dr inż. Aleksandra Sambor

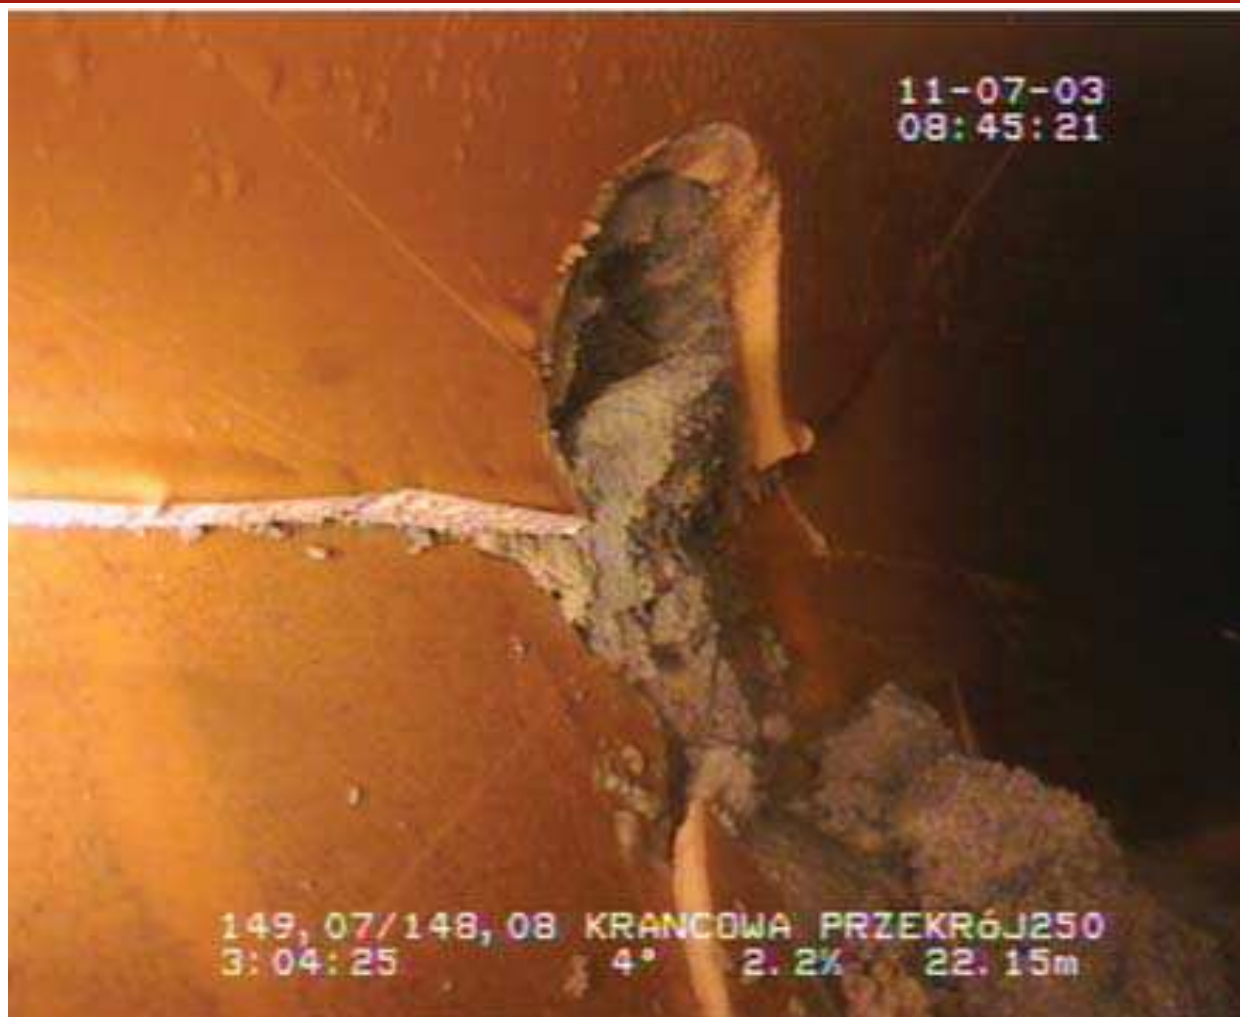
Mechanical damage of PVC-U pipe

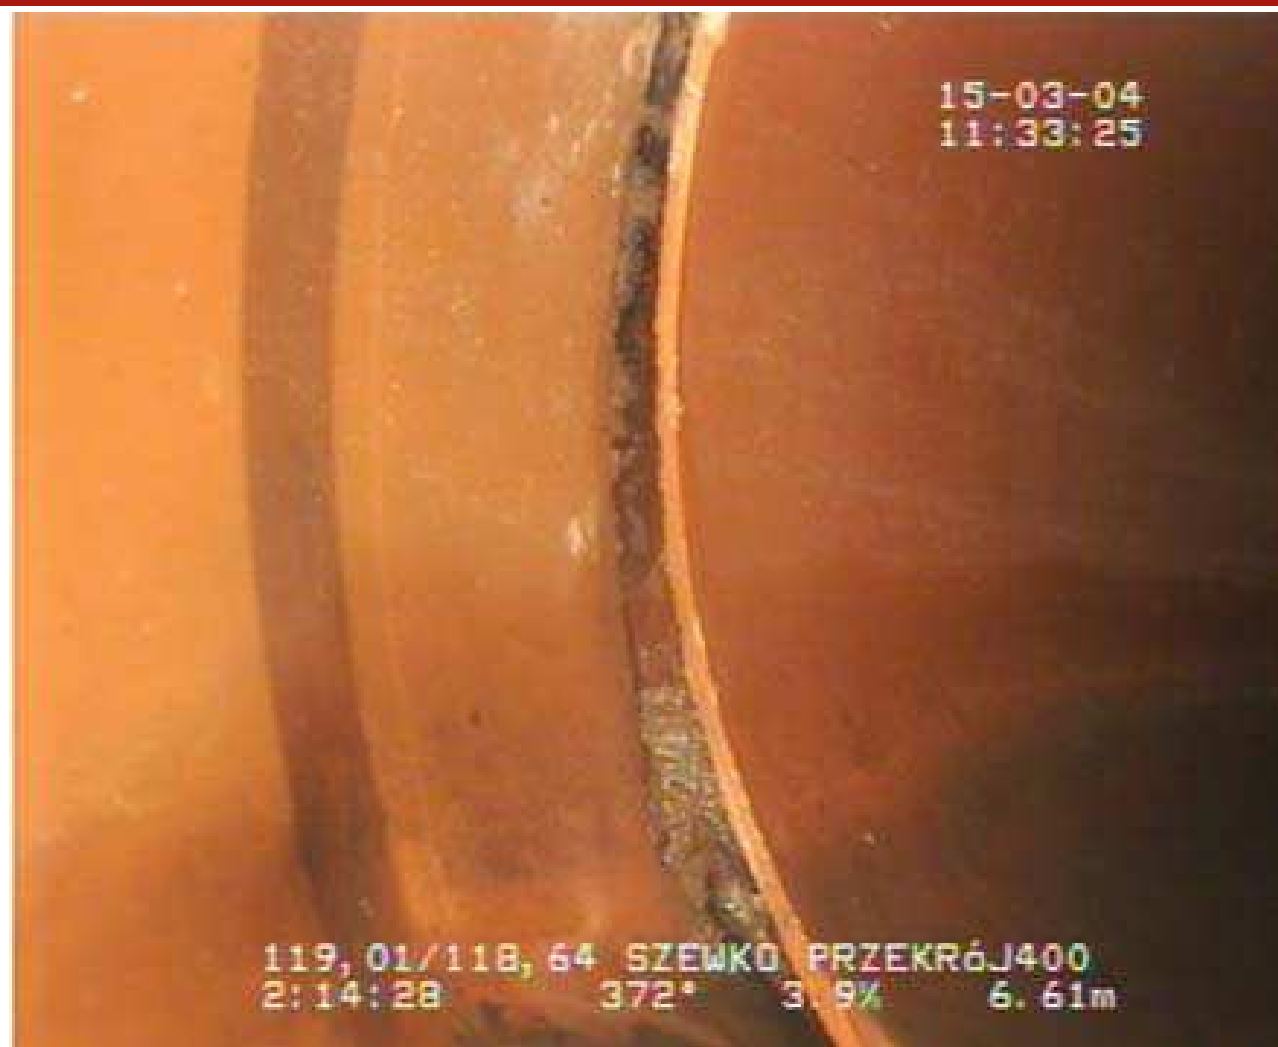
Unsealing joint

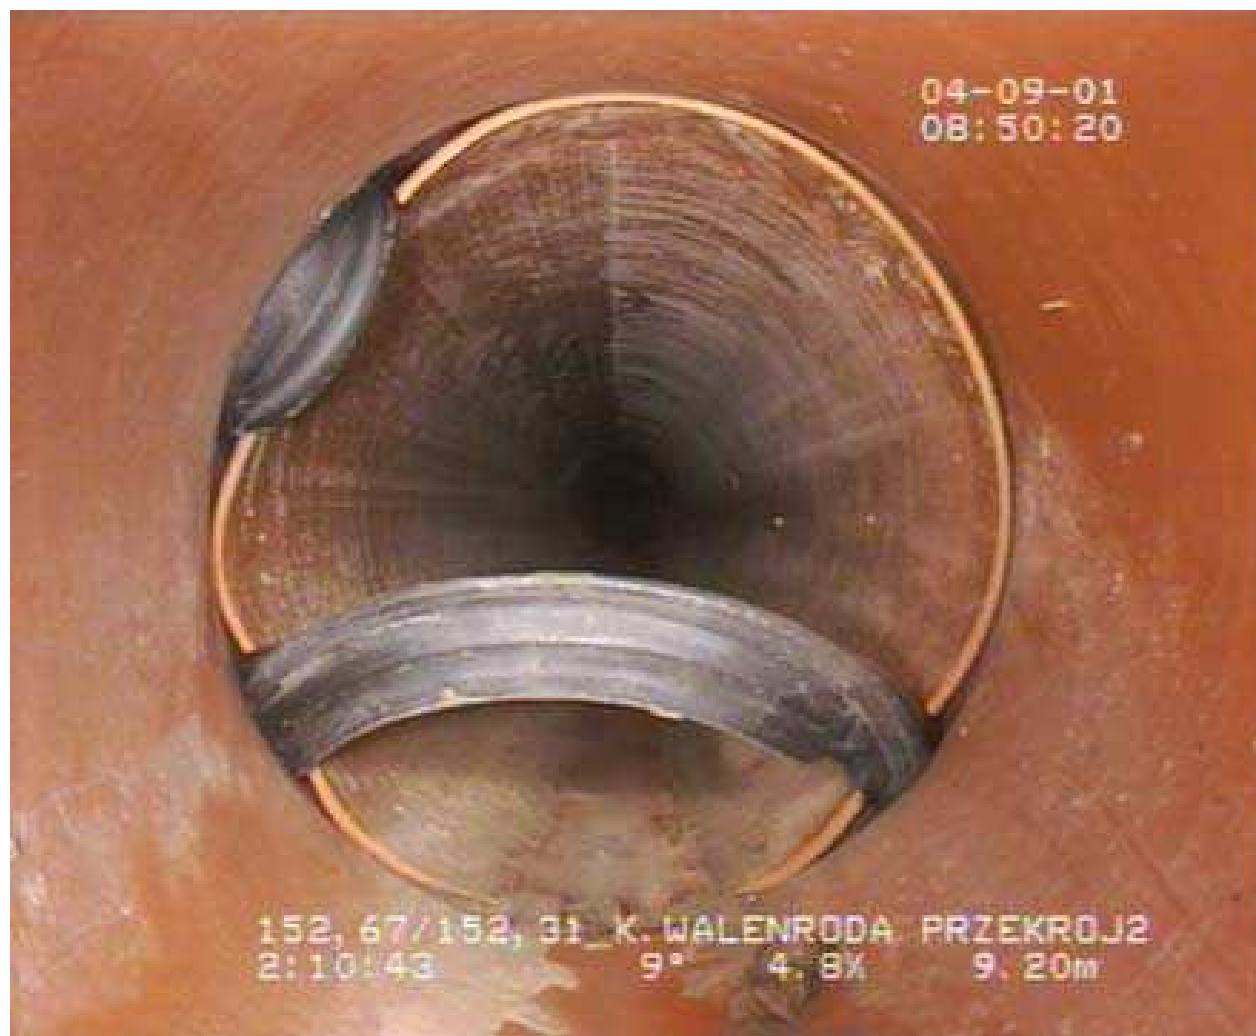
Pushed sealing

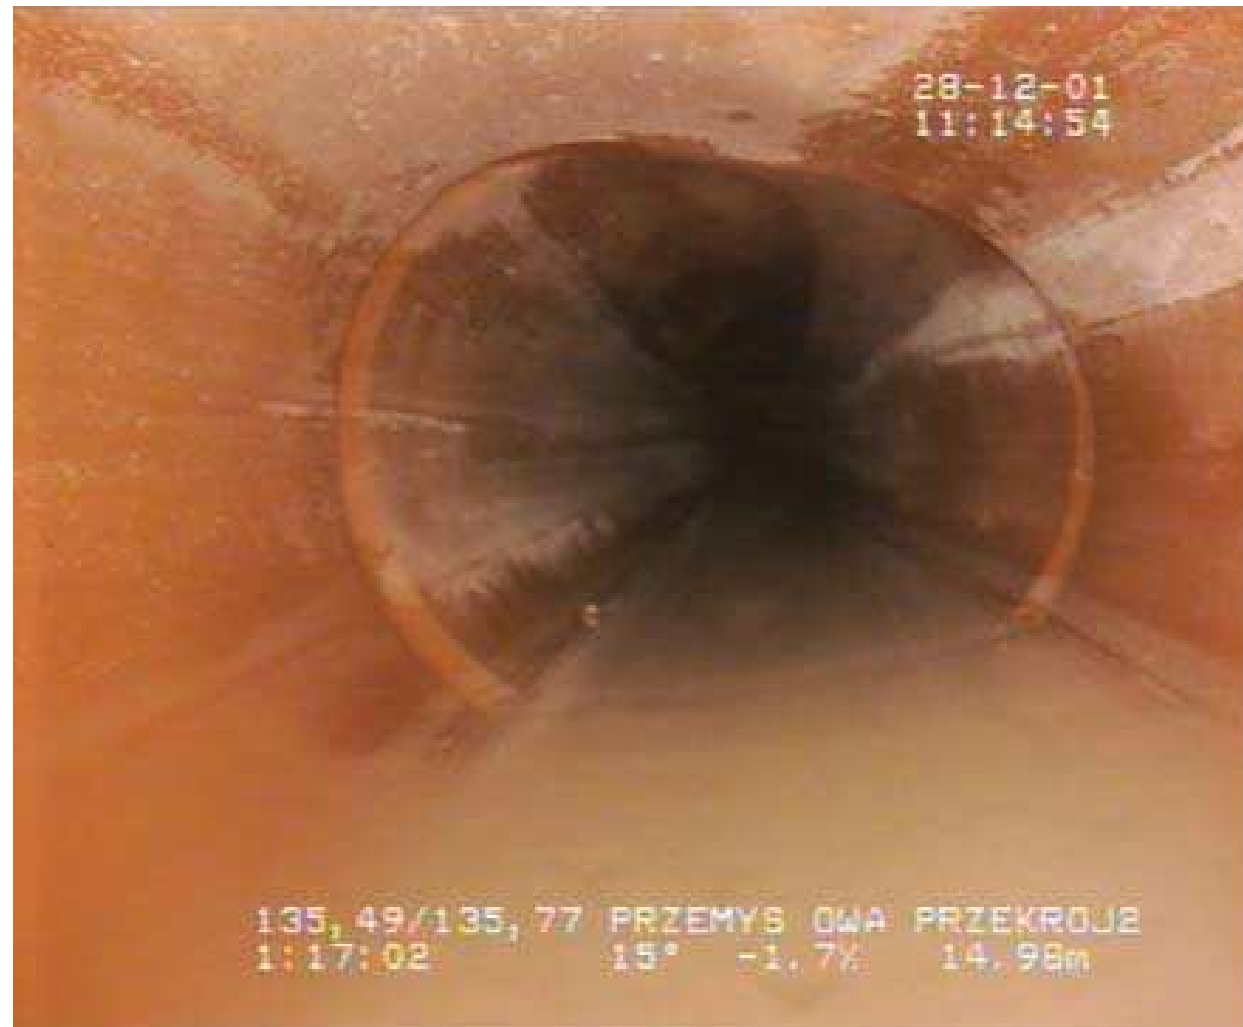
Lack of sealing

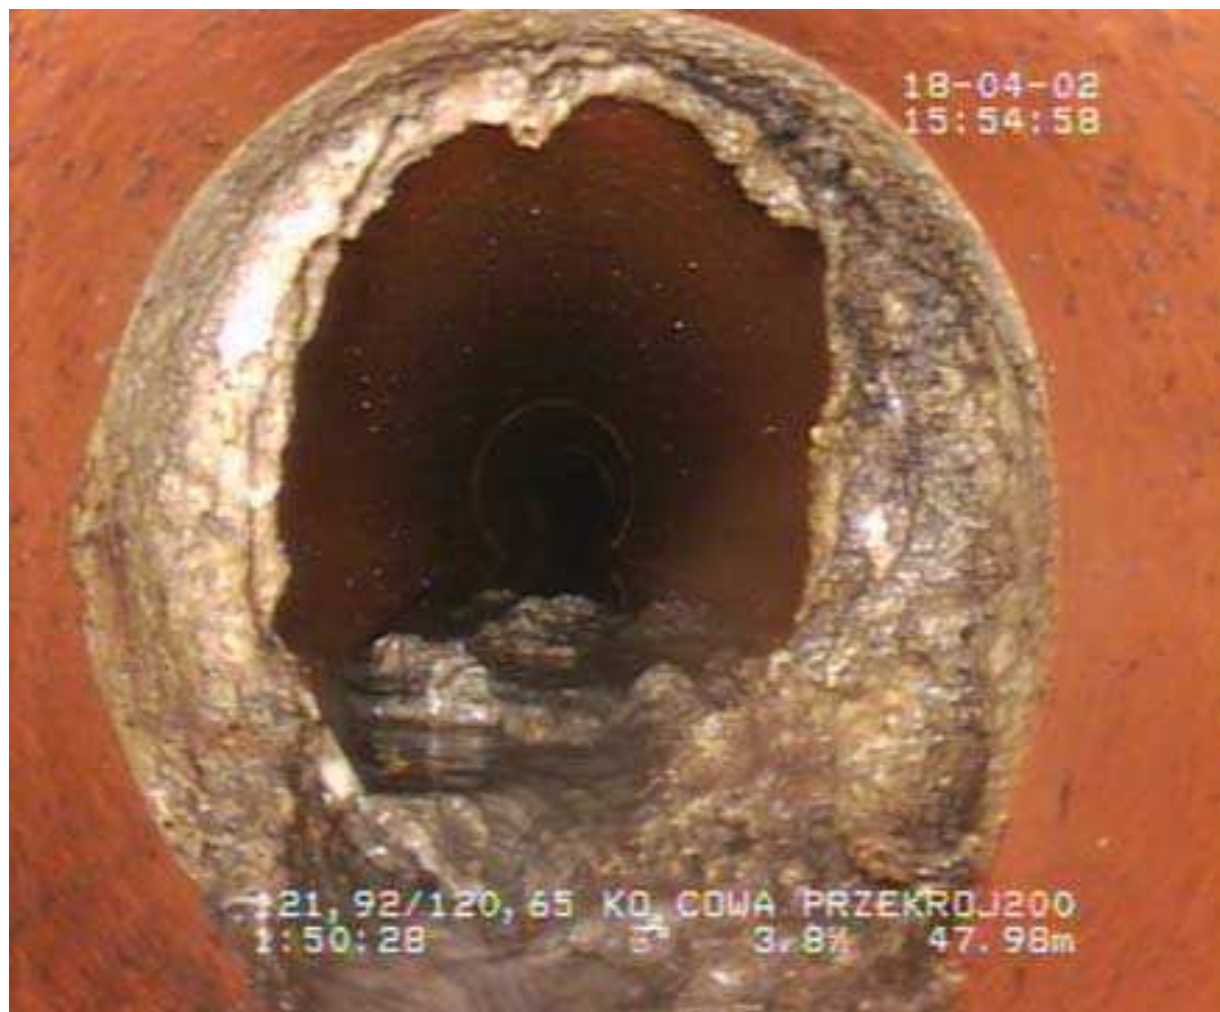
Lack of rubber

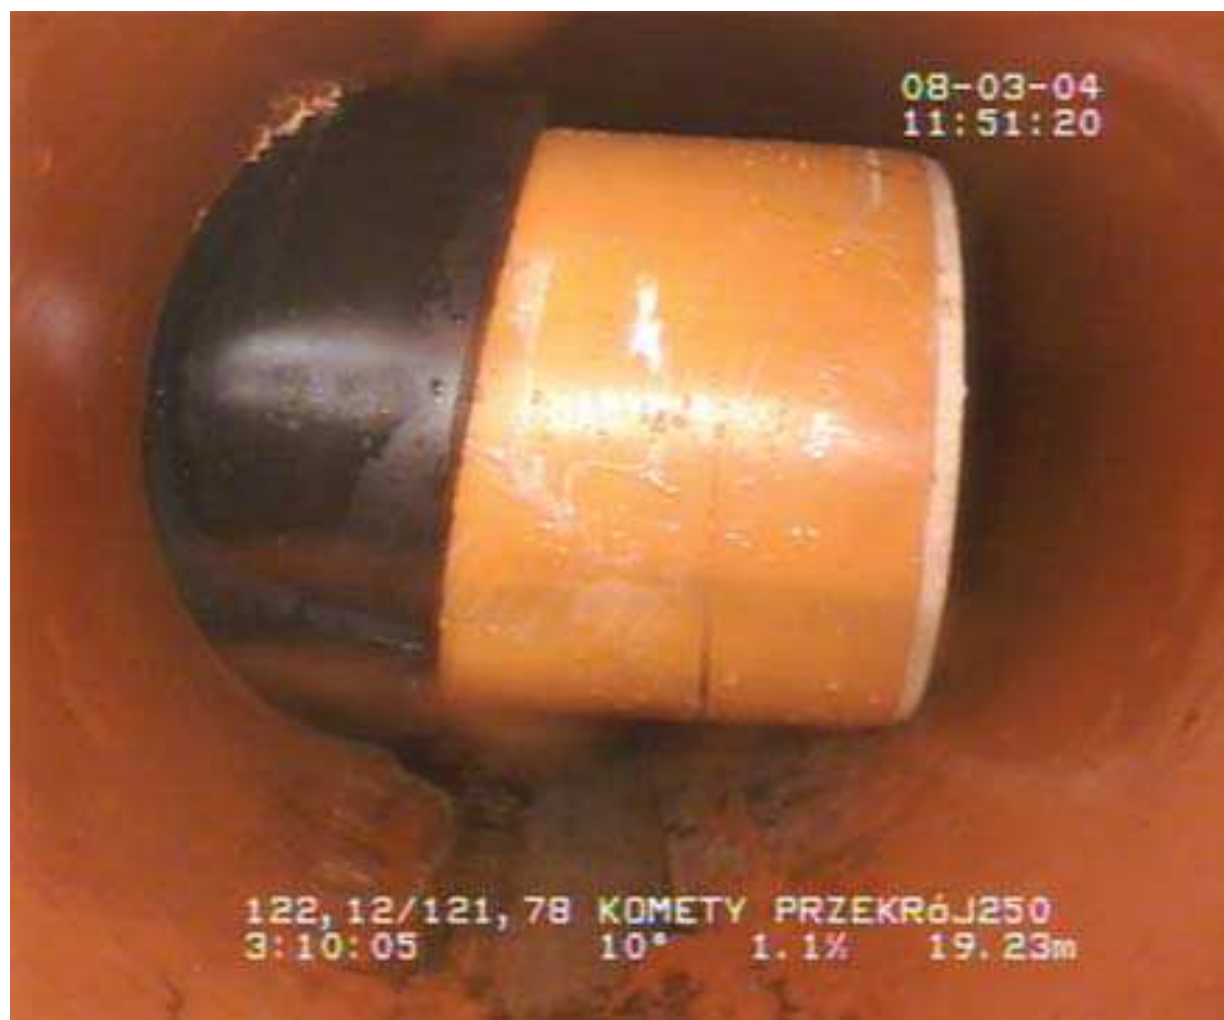
Bad done connection

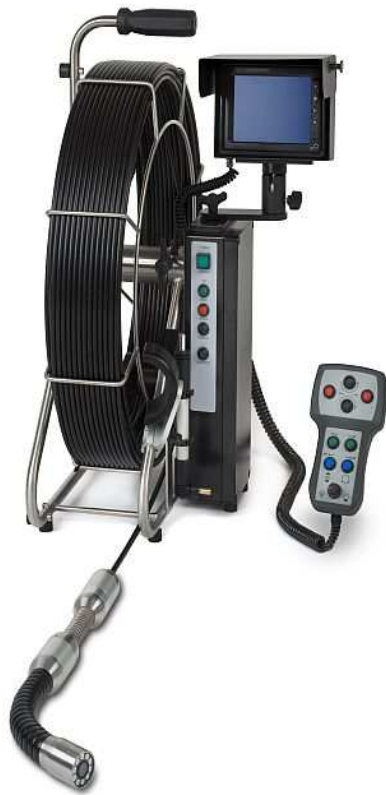
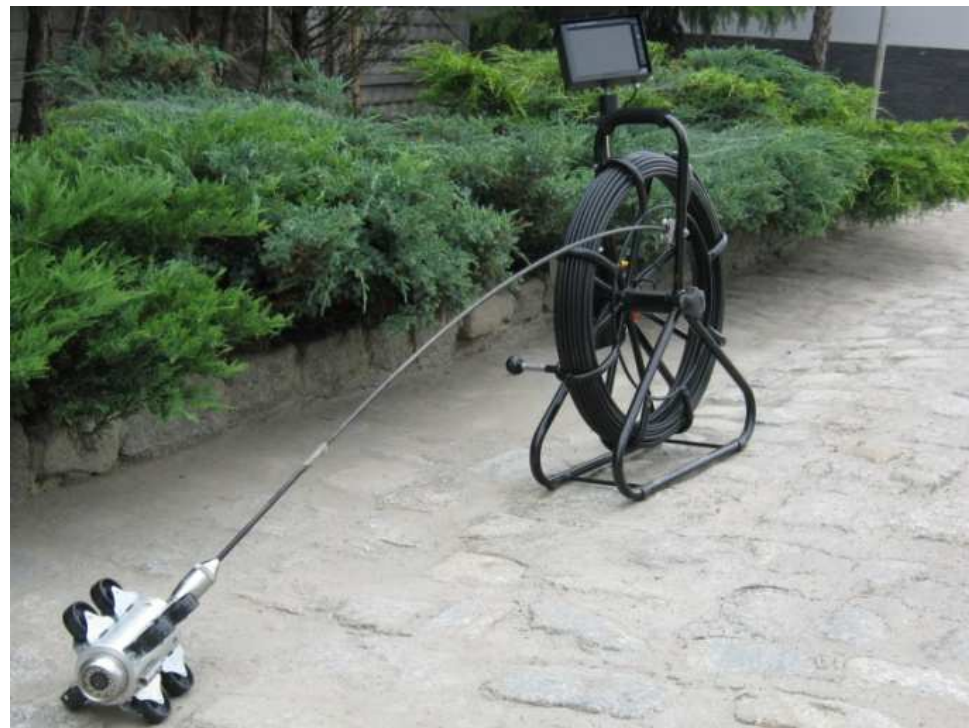
Compact portable inspection systems

- Integrated system
- Consists of the reel, cable with the light and camera and screen
- Used for the pipes: 25 mm, 70 mm, 150 mm, 250 mm or 600 mm
- locates the position of the camera
- Light
- Cannot to be used during the rainfall

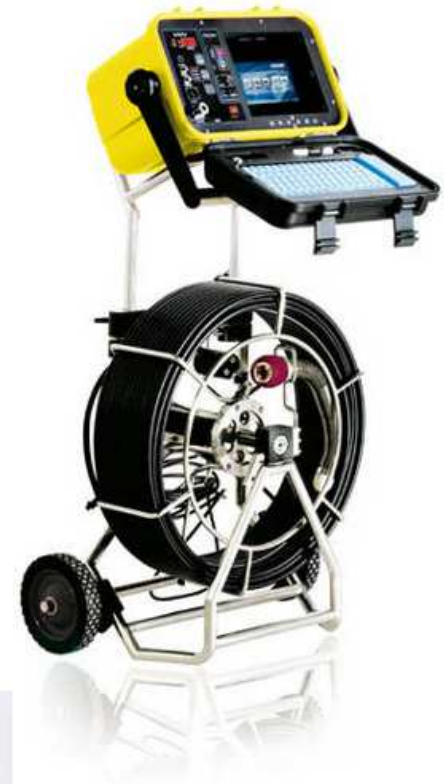
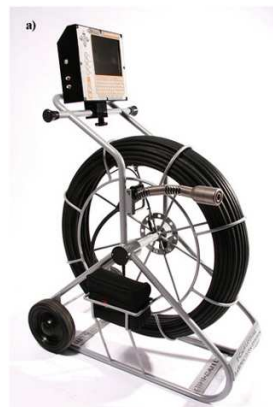
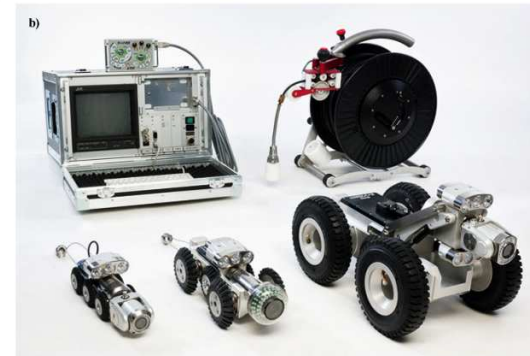
Portable inspection systems with a modular design

- More universal
- Protected against rainfall
- Rotational head

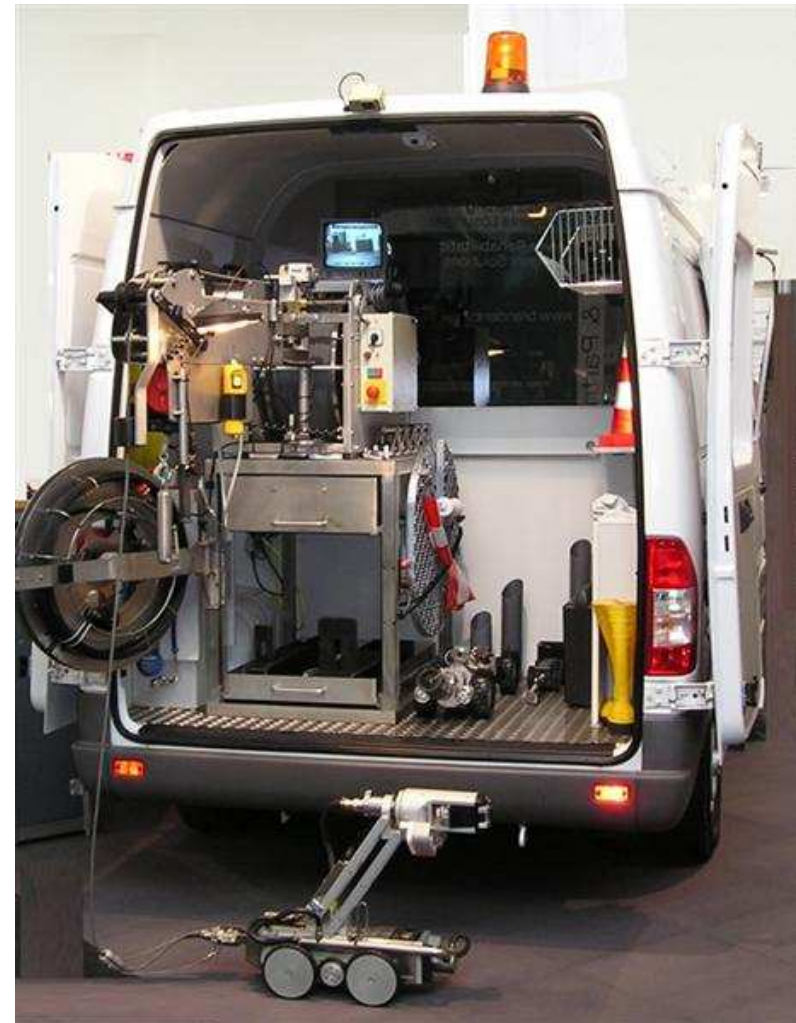
Inspection systems installed in vehicles

- Long-term research
- Control panel inside the vehicle
- Research up to 500 m of the sewer lines

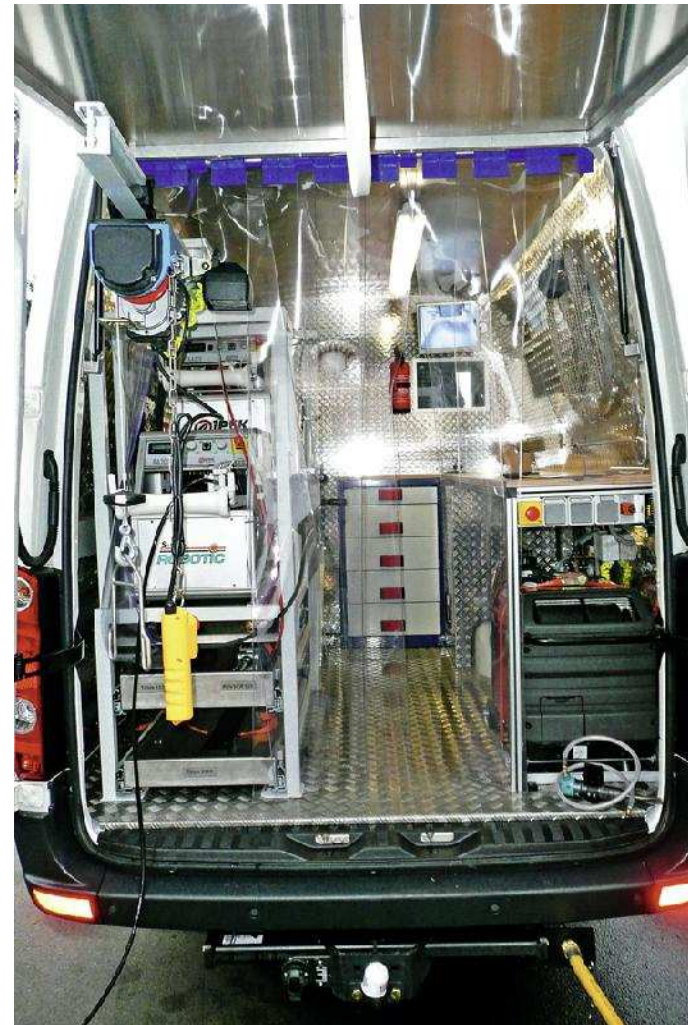
Combi inspection systems

- Pressure cleaning function
- Able to make a leak test

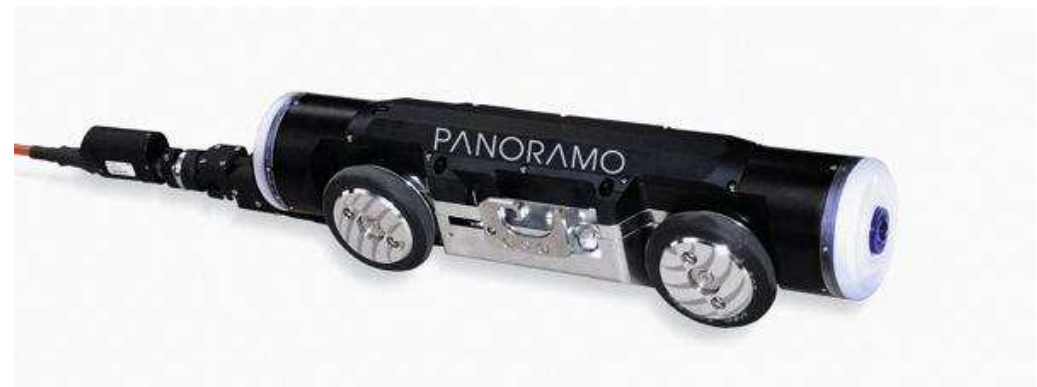
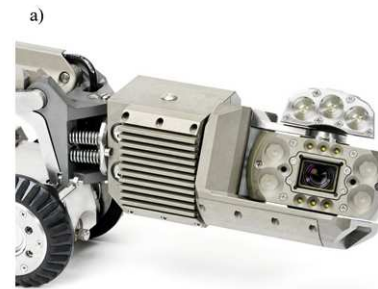
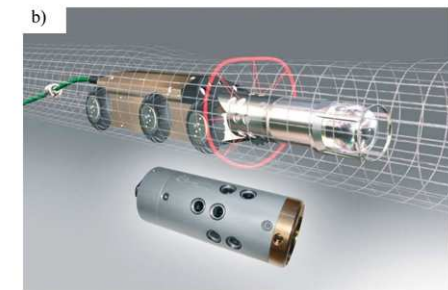
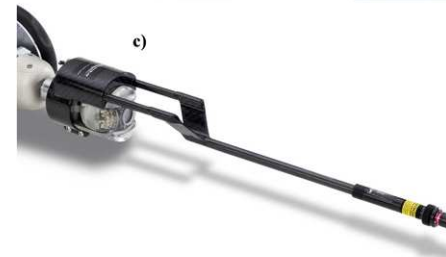
Scanning systems

- Able to make a 3D view
- High accuracy
- High speed of trolley
- 200-800 mm diameter of pipe
- Panoramic view

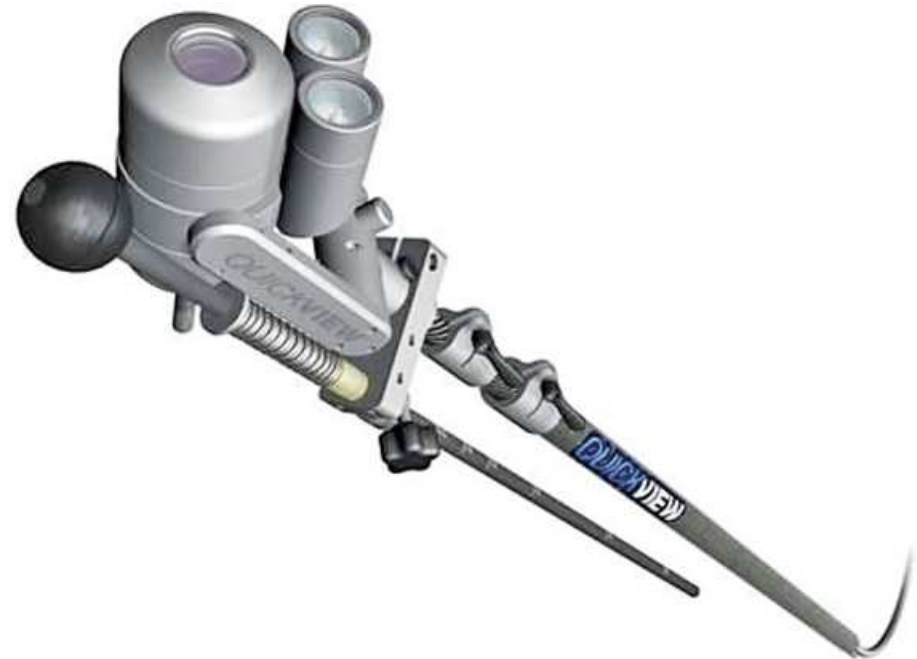
QuickView inspection systems

- Sewer lines do not need to be prepared
- The end with the halogen lighting
- Use zoom
- Does not show the exact location of damage

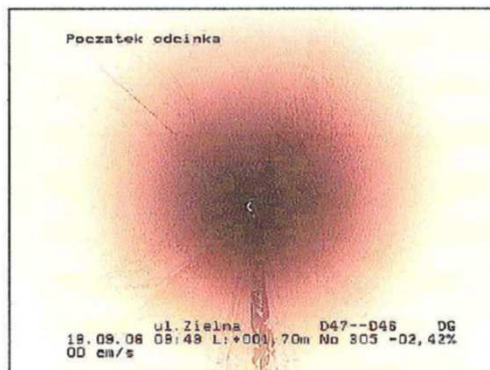
Foto 305
Video
Odległość 1,70
Uszkodz. HA

Foto	Video	Odl. G	Uszk.	Tekst
305		1,70	HA	Początek odcinka
306		5,10	FOTO	Stan jak na fotografii, Foto nr.: 306,00
		16,60	EH	Koniec odcinka

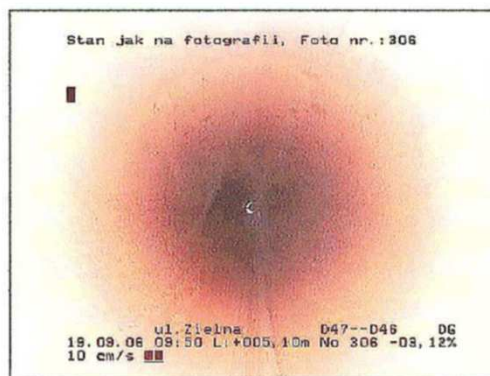
Stan jak na fotografii, Foto nr.: 306,00

Foto 306
Video
Odległość 5,10
Uszkodz. FOTO

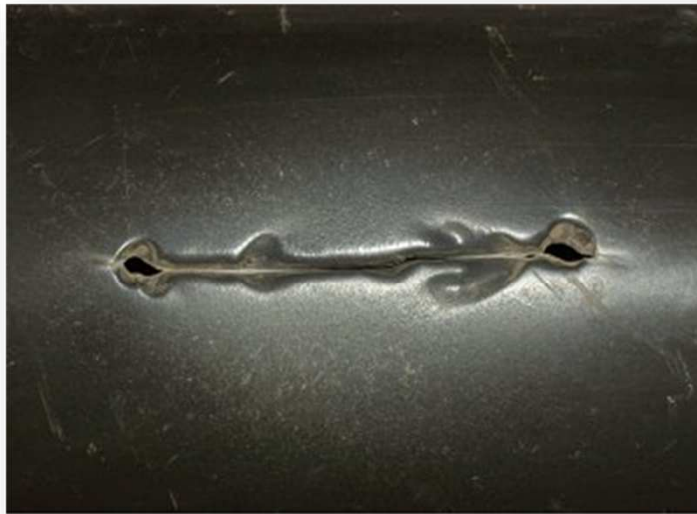
cause - point thrust

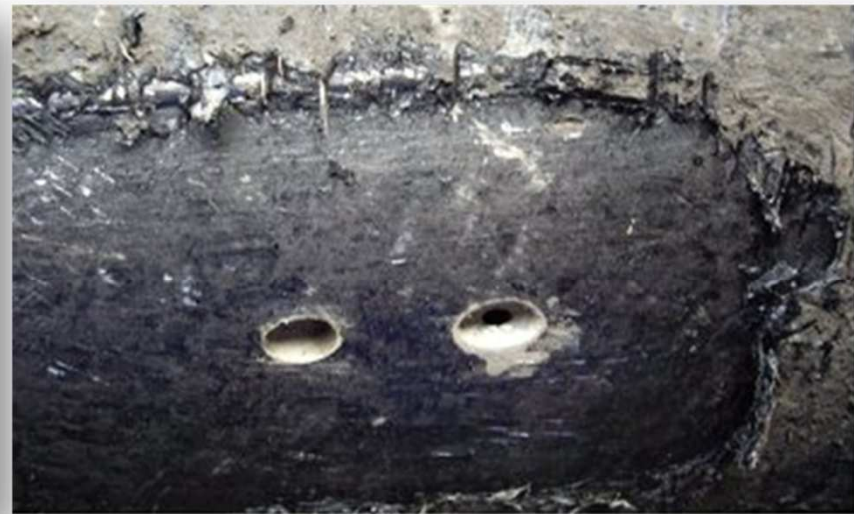
cause - improper material

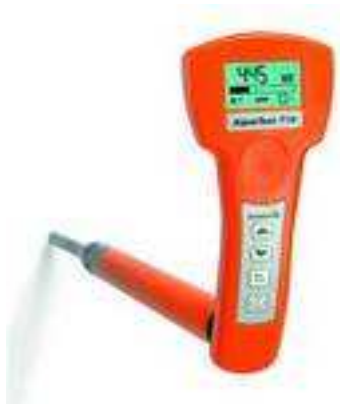
measuring stick

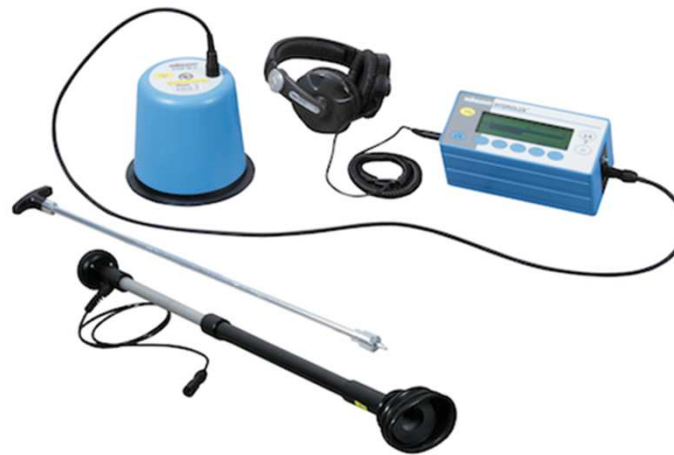
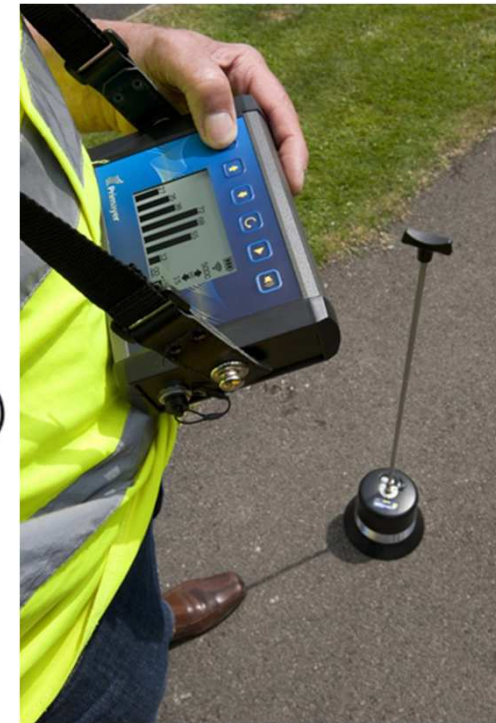
geomicrophone

- base of operation - detecting of sounds of specific frequency
- water flowing through leak - 500-800 Hz
- water hitting the ground - 20-300 Hz
- effective in case of hard, dry ground and metal pipelines

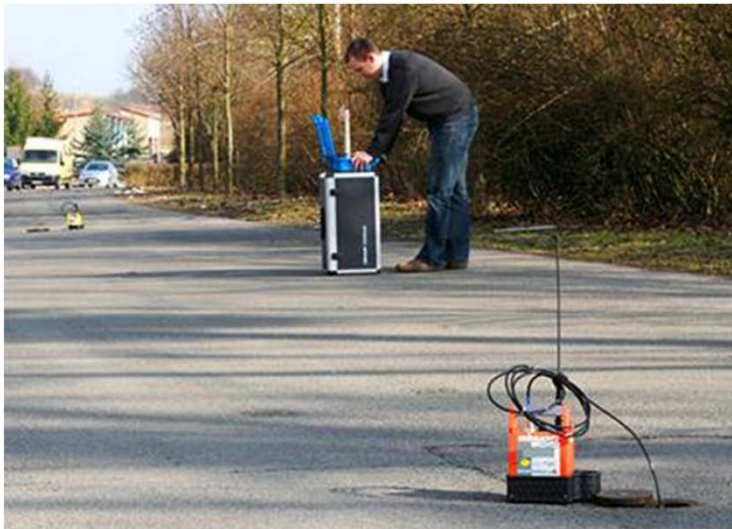
correlator

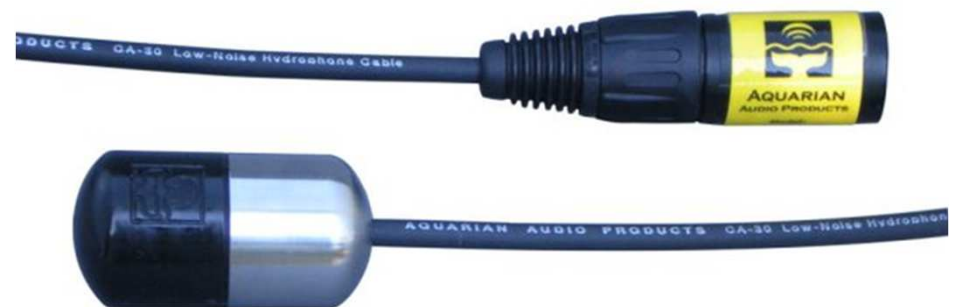
correlator
